**Flood Control Project Maintenance
Levee Inspections**

Fall 2016 Levee Maintenance Deficiency Summary Report

Sutter Maintenance Yard East-West Interceptor

Levee Inspection Report By Mile - Fall 2016

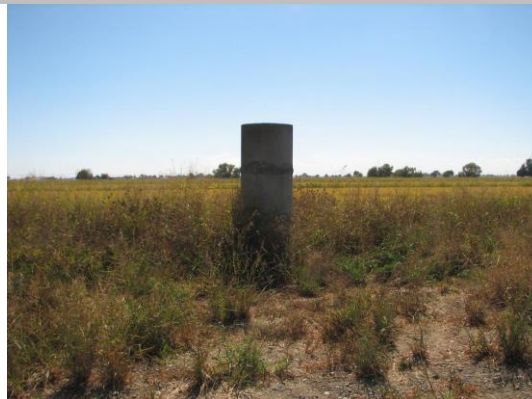
Photo 1 of 2 : UCIP_FA_2016_50336_11391.jpg

Comment Code					
Inspector Comment					
FS_ID:50336 DS_ID:19426 EP_NO: N/A Repair Type: Non-Urgent Crossing Status: Found UCIP Comments: 10/11/2016 Abandoned crossing.(DWR Sutter Yard - afreitag)4/19/2016 Abandoned crossing.5/12/2015 Abandoned crossing. Needs to be properly abandoned.11/17/2014 Same as last inspection.5/12/2014 Same as last inspection.11/4/2013 Same as last inspection.5/15/2013 Same as last inspection.10/16/2012 Pumping plant abandoned. Pipe abandoned and only visible at bottom of concrete standpipe. Pipe needs to be abandoned properly. FIELD_STRUCT_DESC: 12-inch galvanized iron irrigation pipe through the levee 6 feet below the crown. 10 Horsepower (HP) pump in the canal and power pole located on the waterside (WS). 36-inch concrete standpipe located on the landside (LS) shoulder. [Additional Reference(s): DWR Levee Log, Revised 1990. USACE Sacramento O&M Manual 135, May 1953, page 11, Location Section 19, As-builts Drawing No. 50-10-2816] FS Date: 10/12/2016 8:16:33 AM

LM Start	0.74	Rating **	M	Issue No.	44 (cont)
LM End	0.74	Issue Type +	En	Location *	LS

Concrete standpipe on LS shoulder.

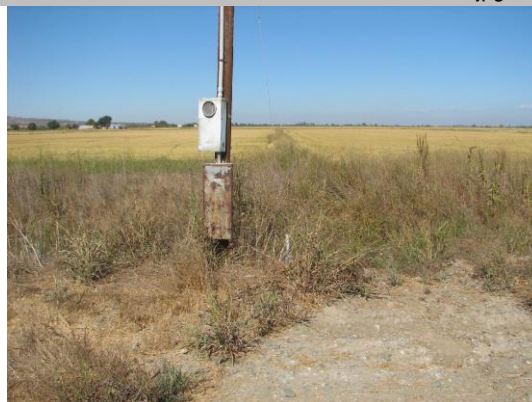
Photo 2 of 2 : UCIP_FA_2016_50336_11390.jpg

Powerpole on WS shoulder.

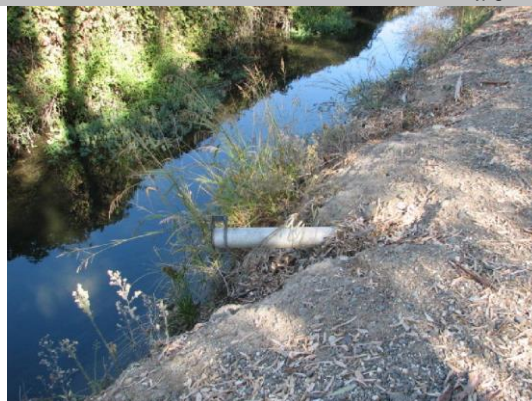
Photo 1 of 2 : UCIP_FA_2016_50343_14335.jpg

Comment Code					
Inspector Comment					
FS_ID:50343 DS_ID:20119 EP_NO: N/A Repair Type: Non-Urgent Crossing Status: Found UCIP Comments: 10/11/2016 Crossing appears to be in good condition.(DWR Sutter Yard - afreitag)4/19/2016 Crossing appears to be in good condition.5/12/2015 Crossing appears in good condition. No noticeable issues to report.11/17/2014 Same as last inspection.5/12/2014 Same as last inspection.11/4/2013 Same as last inspection.5/15/2013 Same as last inspection.10/16/2012 No permit identified for crossing. FIELD_STRUCT_DESC: 5-inch aluminum drainage pipe through the levee, 1 foot below the crown. Flap gate located on the waterside (WS) with concrete headwall block on the landside (LS). No permit has been identified since crossing was field discovered in 2012. FS Date: 10/12/2016 8:42:27 AM

LM Start	1.74	Rating **	M	Issue No.	35 (cont)
LM End	1.74	Issue Type +	En	Location *	WS

pipe with flap gate on WS shoulder.

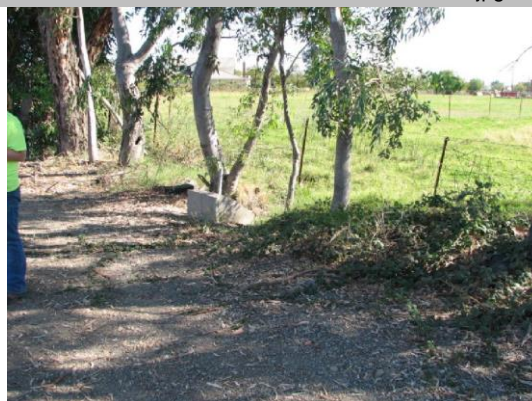
Photo 2 of 2 : UCIP_FA_2016_50343_14334.jpg

Concrete headwall on LS shoulder.

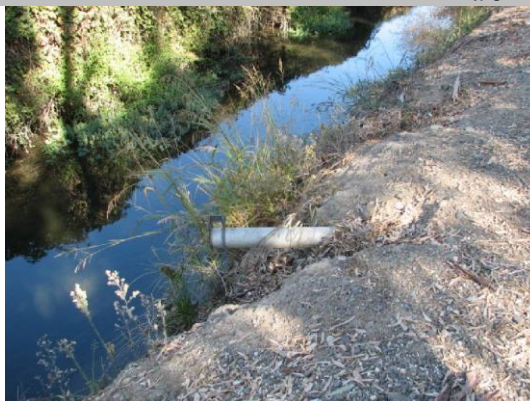
Photo 1 of 1 : UCIP_FA_2016_50344_14341.jpg

Comment Code					
Inspector Comment					
FS_ID:50344					
DS_ID:20122					
EP_NO: N/A					
Repair Type: Non-Urgent					
Crossing Status: Found					
UCIP Comments: 10/11/2016 Crossing appears to be in good condition.(DWR Sutter Yard - afreitag)4/19/2016 Crossing appears to be in good condition.5/12/2015 Crossing appears in good condition. No noticeable issues to report.11/17/2014 Same as last inspection.5/12/2014 Same as last inspection.11/4/2013 Same as last inspection.5/15/2013 Same as last inspection.10/16/2012 No permit identified for crossing.					
FIELD_STRUCT_DESC: 7-inch flexible high-density polyethylene (HDPE) drainage pipe through the levee, 1 foot below the crown. No permit has been identified since crossing was field discovered in 2012.					
FS Date: 10/12/2016 8:51:36 AM

HDPE pipe on upstream side of aluminum pipe shown in picture.

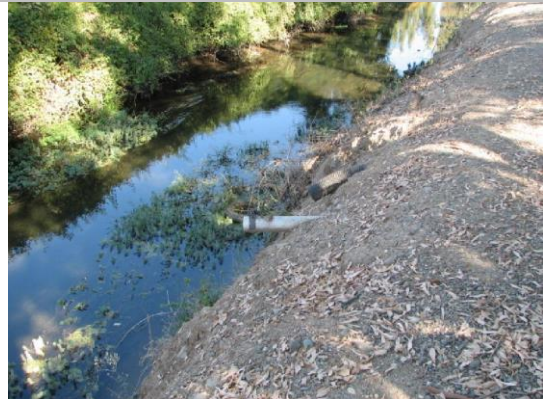
Photo 1 of 2 : UCIP_FA_2016_50345_14339.jpg

Comment Code					
Inspector Comment					
FS_ID:50345 DS_ID:20120 EP_NO: N/A Repair Type: Non-Urgent Crossing Status: Found UCIP Comments: 10/11/2016 Crossing appears to be in good condition. (DWR Sutter Yard - afreitag)4/19/2016 Crossing appears to be in good condition.5/12/2015 Crossing appears in good condition. No noticeable issues to report.11/17/2014 Same as last inspection.5/12/2014 Same as last inspection.11/4/2013 Same as last inspection.5/15/2013 Same as last inspection.10/16/2012 No permit identified for crossing. FIELD_STRUCT_DESC: 5-inch aluminum drainage pipe through the levee, 1 foot below the crown. Flap gate located on the waterside (WS) with concrete headwall block on the landside (LS). No permit has been identified since crossing was field discovered in 2012. FS Date: 10/12/2016 9:01:02 AM

LM Start	1.76	Rating **	M	Issue No.	37 (cont)
LM End	1.76	Issue Type +	En	Location *	WS

Pipe and flap gate on WS shoulder.

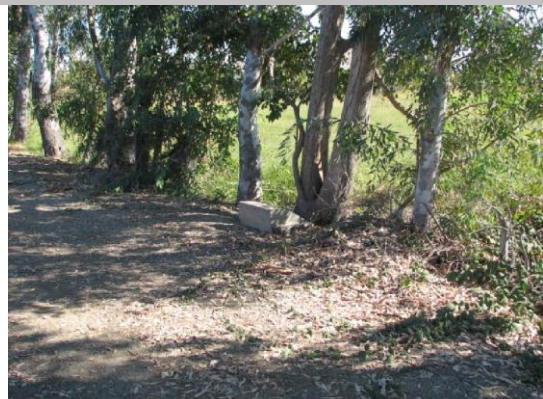
Photo 2 of 2 : UCIP_FA_2016_50345_14338.jpg

Concrete headwall on LS shoulder.

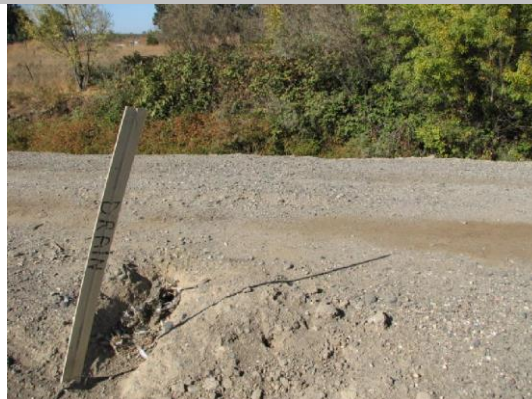
Photo 1 of 2 : UCIP_FA_2016_50348_21743.jpg

FS_ID:50348
DS_ID:20123
EP_NO: N/A
Repair Type: Non-Urgent
Crossing Status: Found
UCIP Comments: 10/11/2016 Crossing appears to be in good condition.(DWR Sutter Yard - afreitag)4/19/2016 Crossing appears to be in good condition.5/12/2015 Crossing appears in good condition. No noticeable issues to report.11/17/2014 Same as last inspection.5/12/2014 Same as last inspection.5/22/2013 Erosion under pipe outlet has been repaired. Bank lined with rock to prevent future erosion.5/15/2013 Flexible pipe has been replaced with 6.5 inch steel with flap gate on WS. Erosion under WS outlet.11/4/2013 Same as last inspection.10/16/2012 No permit identified for crossing. FIELD_STRUCT_DESC: 7-inch flexible high-density polyethylene (HDPE) drainage pipe through the levee, 1 foot below the crown. Signage for crossing is visible on the landside (LS) shoulder. Outlet visible on the waterside (WS) shoulder. No permit has been identified since crossing was field discovered in 2012.

LM Start	1.93	Rating **	M	Issue No.	39 (cont)
LM End	1.93	Issue Type +	En	Location *	LS

Inlet and signage for crossing on LS shoulder.

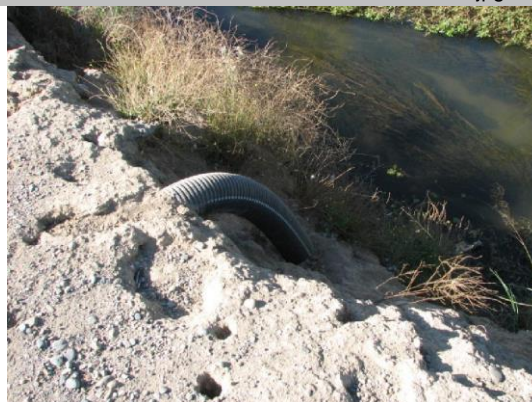
Photo 2 of 2 : UCIP_FA_2016_50348_21742.jpg

Outlet for crossing on WS shoulder.

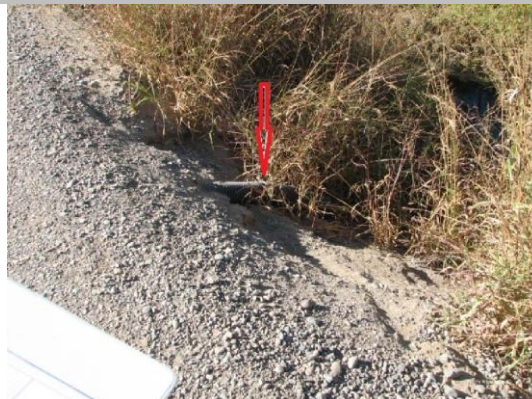
Photo 1 of 2 : UCIP_FA_2016_50349_21749.jpg

Comment Code					
Inspector Comment					
FS_ID:50349 DS_ID:20124 EP_NO: N/A Repair Type: Non-Urgent Crossing Status: Found UCIP Comments: 10/11/2016 Crossing appears to be in good condition.(DWR Sutter Yard - afreitag)4/19/2016 Crossing appears to be in good condition.5/12/2015 Crossing appears in good condition. No noticeable issues to report.11/17/2014 Same as last inspection.5/12/2014 Same as last inspection.11/4/2013 Same as last inspection.5/22/2013 Erosion under pipe outlet has been repaired and bank lined with rock to prevent future erosion.5/15/2013 Flexible pipe has been replaced with 6.5 inch steel with flap gate on WS outlet. Erosion under WS outlet.10/16/2012 No permit identified for this crossing. FIELD_STRUCT_DESC: 7-inch flexible high-density polyethylene (HDPE) drainage pipe through the levee, 1 foot below the crown. Pipe visible on the waterside (WS) shoulder. Intake with grate visible on the landside (LS). No permit has been identified since crossing was field discovered in 2012. FS Date: 10/12/2016 9:16:04 AM

LM Start	1.97	Rating **	M	Issue No.	40 (cont)
LM End	1.97	Issue Type +	En	Location *	LS

Pipe on WS shoulder.

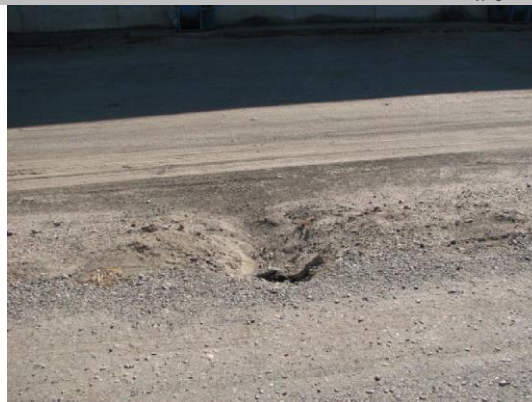
Photo 2 of 2 : UCIP_FA_2016_50349_21748.jpg

Pipe on LS shoulder.

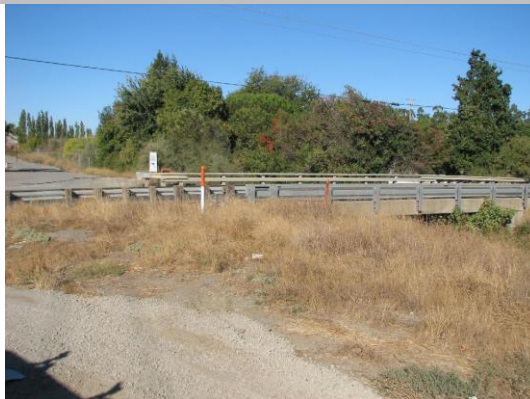
Photo 1 of 2 : UCIP_FA_2016_50351_14369.jpg

FS_ID:50351
DS_ID:20125
EP_NO: N/A
Repair Type: Non-Urgent
Crossing Status: Found
UCIP Comments: 10/11/2016 Crossing appears to be in good condition.(DWR Sutter Yard - afreitag)4/19/2016 Crossing appears to be in good condition.5/12/2015 Crossing appears in good condition. No noticeable issues to report.11/17/2014 Same as last inspection.5/12/2014 Same as last inspection.11/4/2013 Same as last inspection.5/15/2013 Same as last inspection.10/16/2012 No permit identified for this crossing.
FIELD_STRUCT_DESC: Steel fiber optic conduit through the levee at an unknown depth below the crown. Crossing is located on the east side of Township road bridge. Marker visible on east side of N. Township Drive, south of interceptor. Owner is Pacific and their contact number is 1-877-735-7366. No permit has been identified since crossing was field discovered in 2012.
FS Date: 10/12/2016 9:21:30 AM

LM Start	2.03	Rating **	M	Issue No.	41 (cont)
LM End	2.03	Issue Type +	En	Location *	LS

Marker on east side of N Township Drive, south of interceptor.

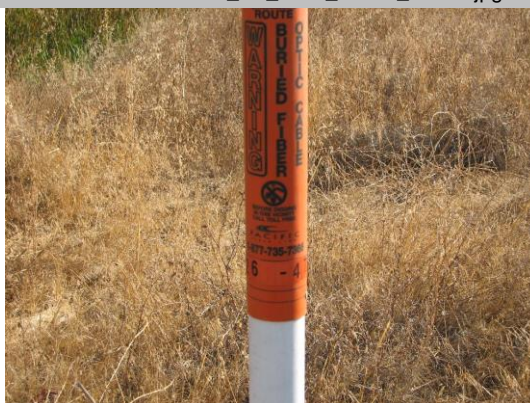
Photo 2 of 2 : UCIP_FA_2016_50351_14368.jpg

Closeup of marker.

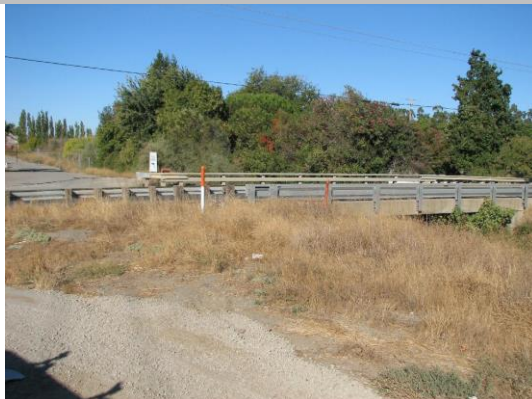
Photo 1 of 2 : UCIP_FA_2016_50352_14367.jpg

Comment Code					
Inspector Comment					
FS_ID:50352					
DS_ID:20126					
EP_NO: N/A					
Repair Type: Non-Urgent					
Crossing Status: Found					
UCIP Comments: 10/11/2016 Crossing appears to be in good condition.(DWR Sutter Yard - afreitag)4/19/2016 Crossing appears to be in good condition.5/12/2015 Crossing appears in good condition. No noticeable issues to report.11/17/2014 Same as last inspection.5/12/2014 Same as last inspection.11/4/2013 Same as last inspection.5/15/2013 Same as last inspection.10/16/2012 No permit identified for this crossing.					
FIELD_STRUCT_DESC: Steel gas line crossing through the levee at an unknown depth below the crown. Sign visible on the landside (LS). No permit has been identified since crossing was field discovered in 2012.					
FS Date: 10/12/2016 9:24:54 AM

LM Start	2.03	Rating **	M	Issue No.	42 (cont)
LM End	2.03	Issue Type +	En	Location *	LS

Gasline marker on east side of N Township Road south of interceptor

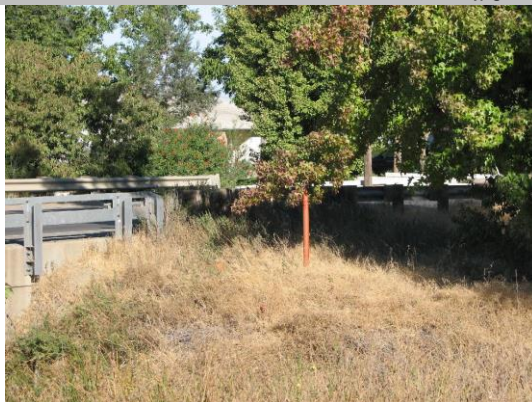
Photo 2 of 2 : UCIP_FA_2016_50352_14366.jpg

Gasline marker on east side of N Township Road North of interceptor

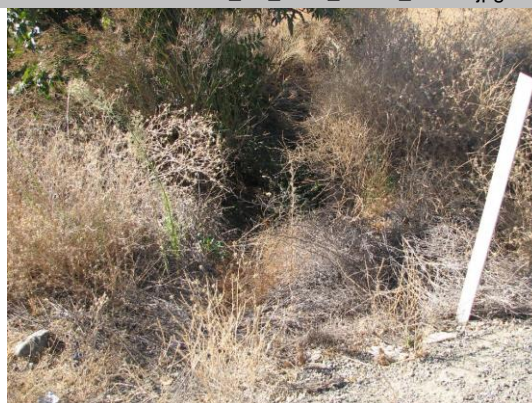
Photo 2 of 2 : UCIP_FA_2016_50353_14373.jpg

FS_ID:50353
DS_ID:20127
EP_NO: N/A
Repair Type: Non-Urgent
Crossing Status: Found
UCIP Comments: 10/11/2016 WS flap gate is being overgrown by blackberries that could possibly hinder its operation. They should be sprayed and cleared back.(DWR Sutter Yard - afreitag)4/19/2016 Crossing appears to be in good condition.5/12/2015 Crossing appears in good condition. No noticeable issues to report.11/17/2014 Same as last inspection.5/12/2014 Same as last inspection.5/15/2013 Same as last inspection.11/4/2013 Same as last inspection.10/16/2012 No permit identified for this crossing.
FIELD_STRUCT_DESC: 18-inch asphalt coated corrugated metal drainage pipe through the levee, 6 feet below the crown. Flap gate is located on the waterside (WS). Pipe is visible on the landside (LS) toe. No permit has been identified since crossing was field discovered in 2012.
FS Date: 10/12/2016 9:27:19 AM

Location of pipe on LS toe.
